Cooler leaking from bottom

Reasons for float not locking

95% of leaks are due to the float valve not locking properly

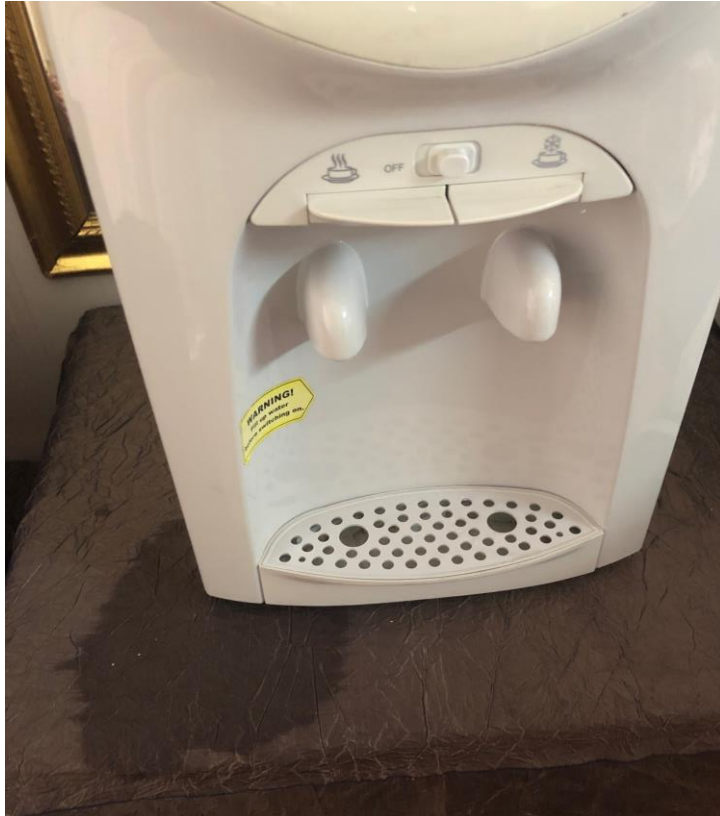
Float Valve

The float regulates the flow of water into the tank. If it doesn't lock properly, the tank will overflow, and water will run over in the inside of the machine and out the bottom.

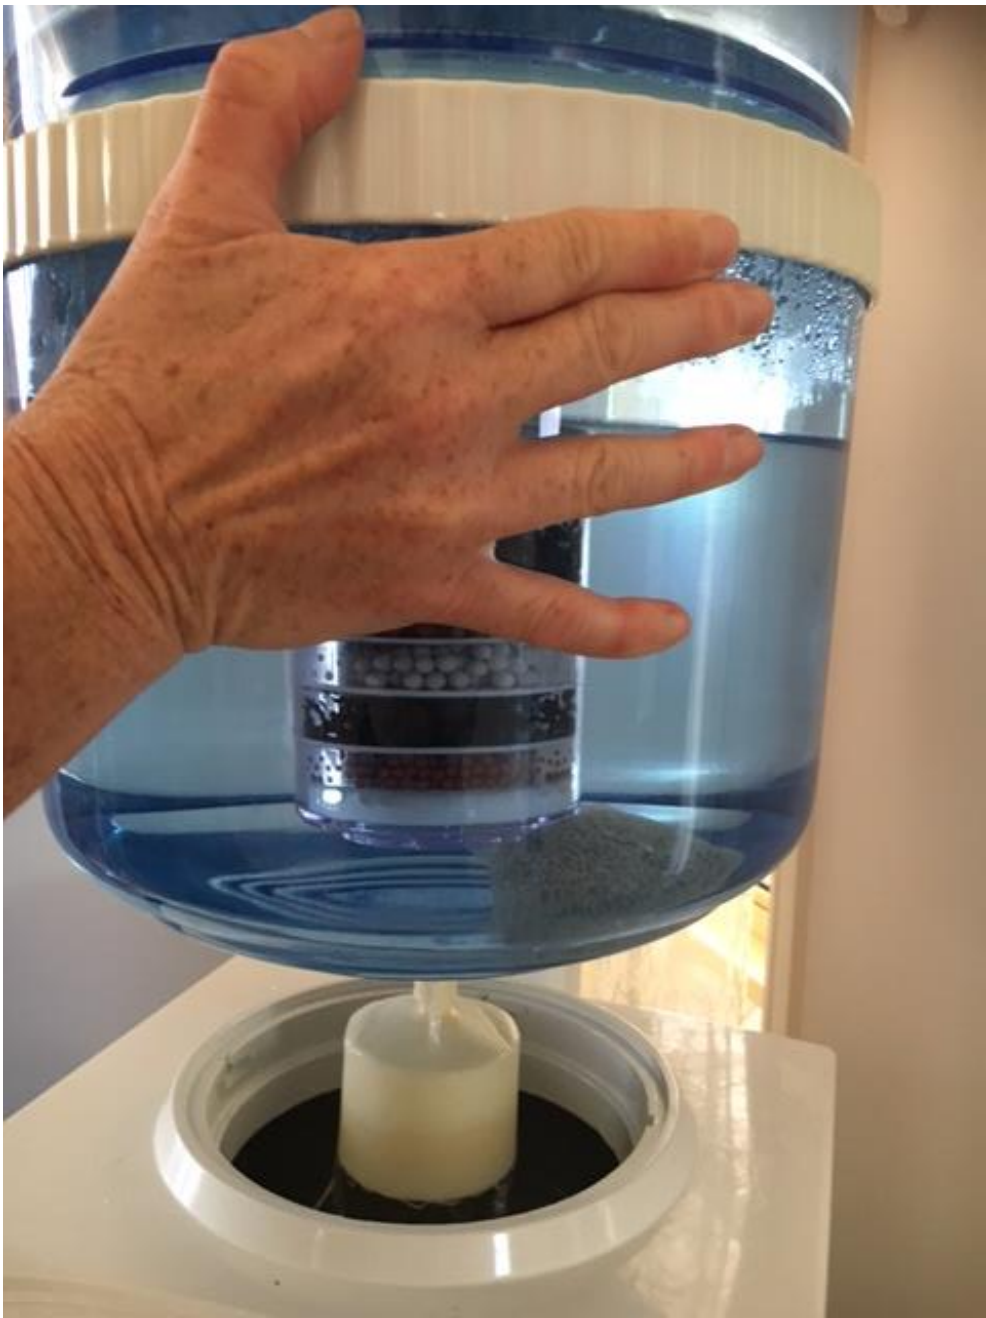
Lift the bowl out of the machine - be careful – the top & bottom bowl are separate pieces - pick up on **bottom** bowl part !
Obviously this will be easier to do when the water level in the bottle is low.

Have a bucket handy to place the bowl into

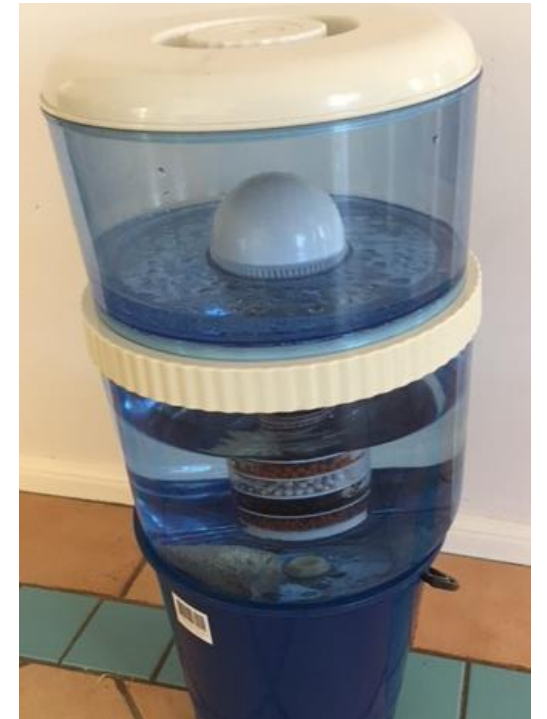
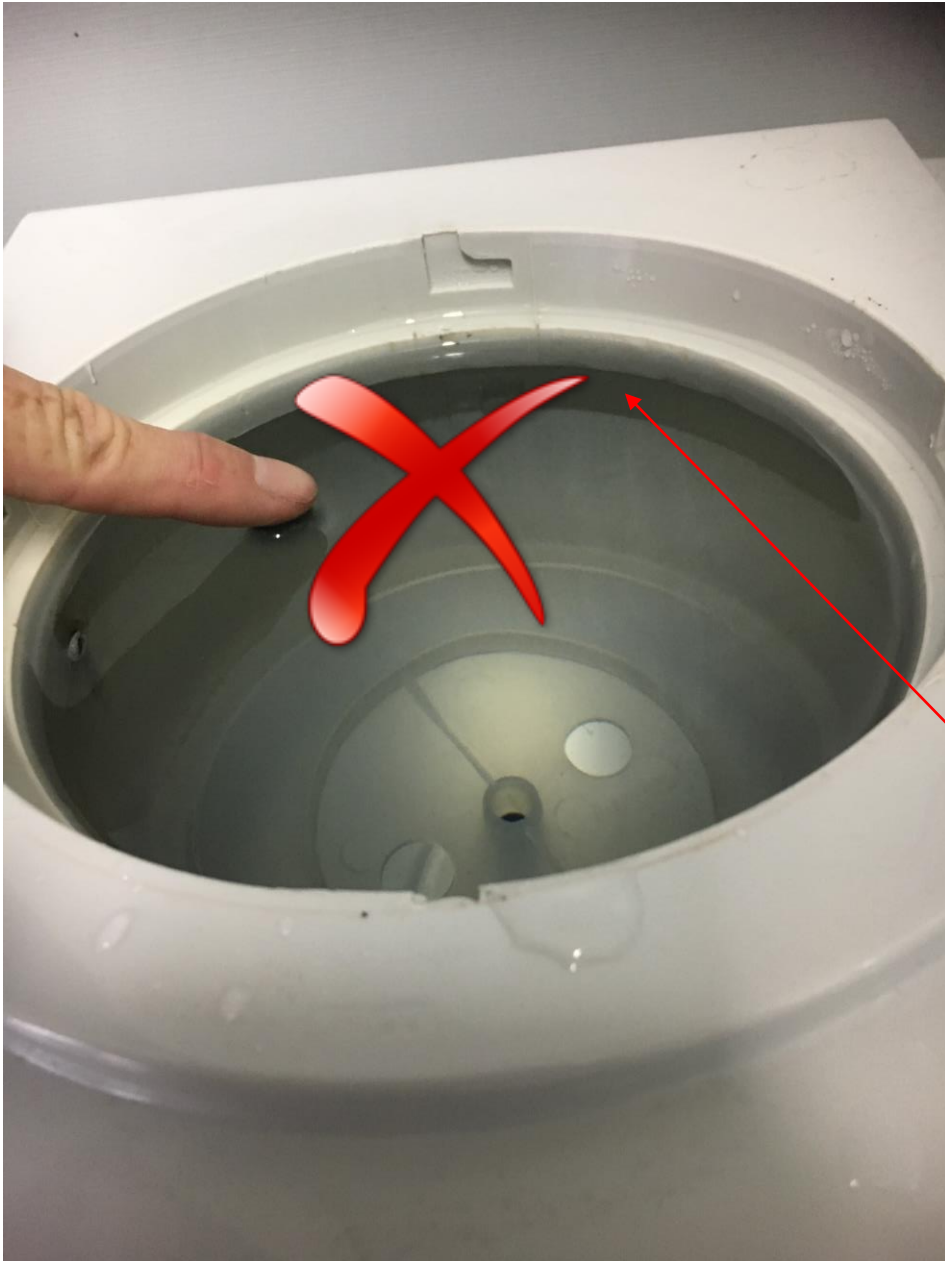
Check the **water level** in the **tank** – if it's all the way to the top (or close to the top), it means the float valve is not locking properly and slowly fills up the tank until it spills over on the inside and then run down the side and out the bottom of the cooler.

There is a small gab between the tank and the cover where water spills over on the inside of the machine

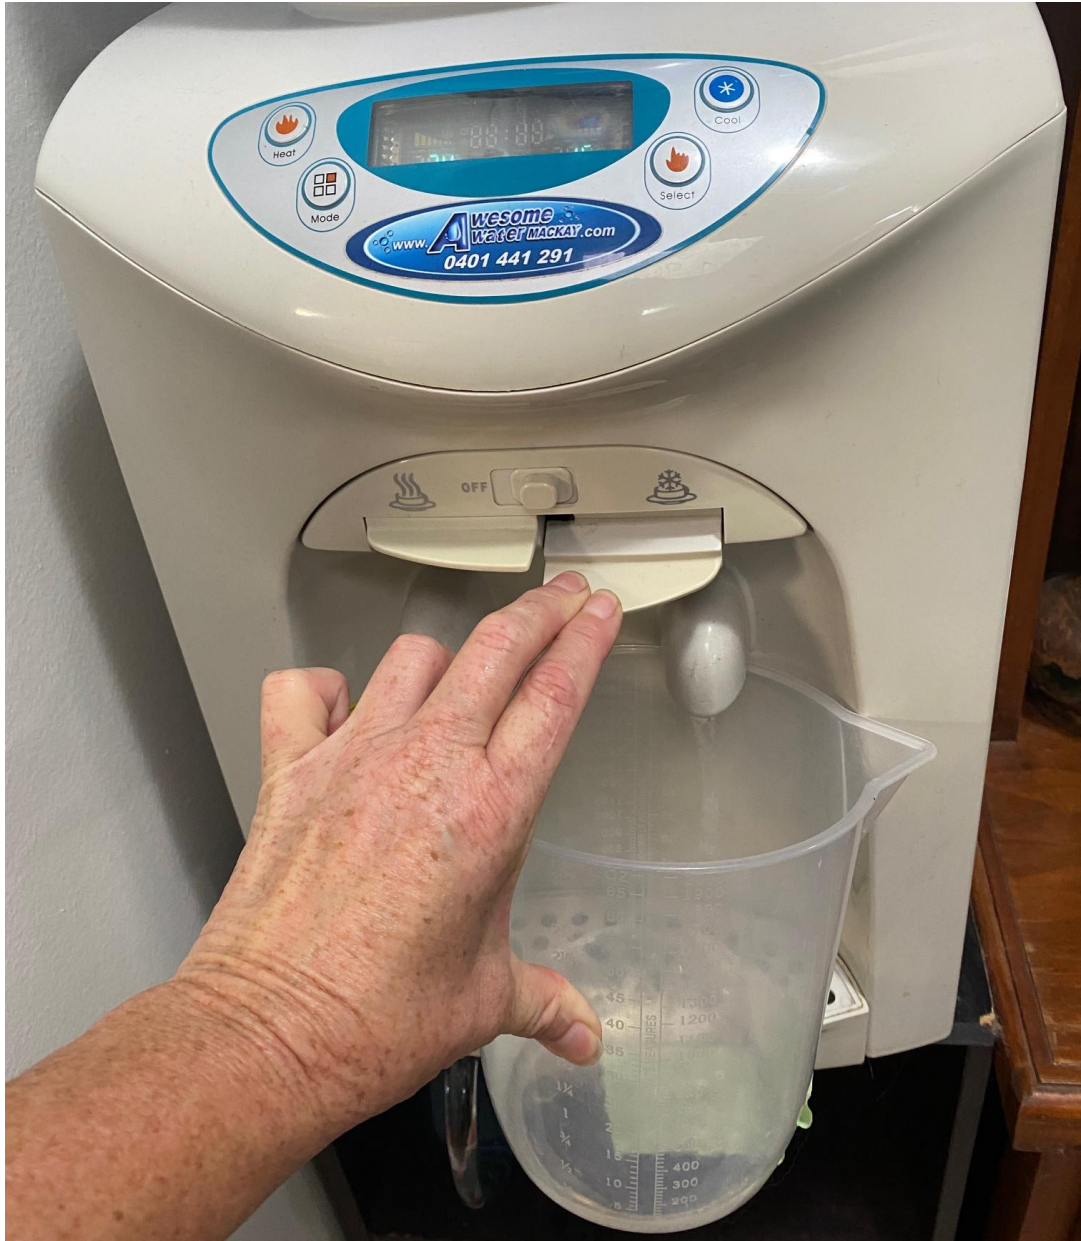
Drain the water in the tank by running the **cold tap** until the water level in the tank is just above the plastic plate.

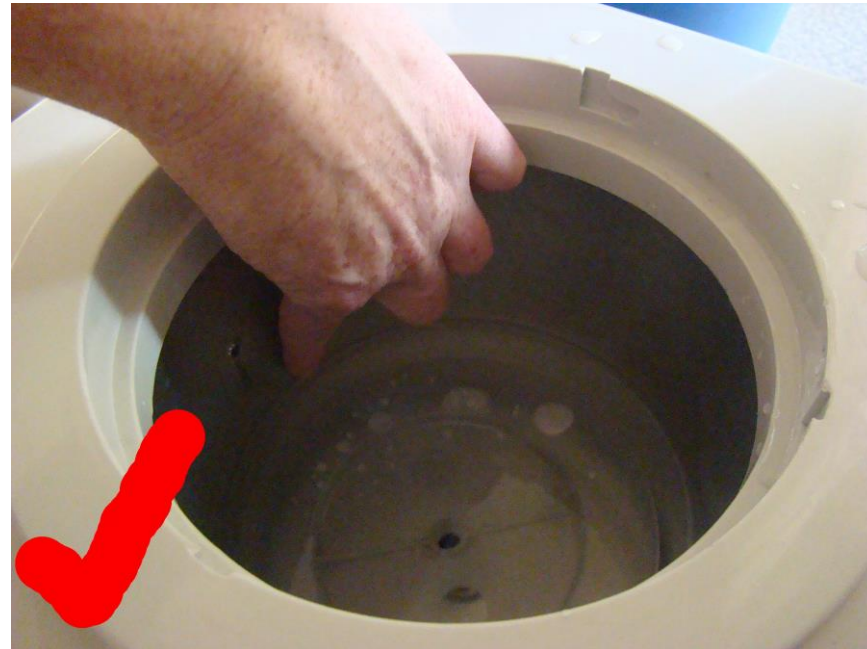
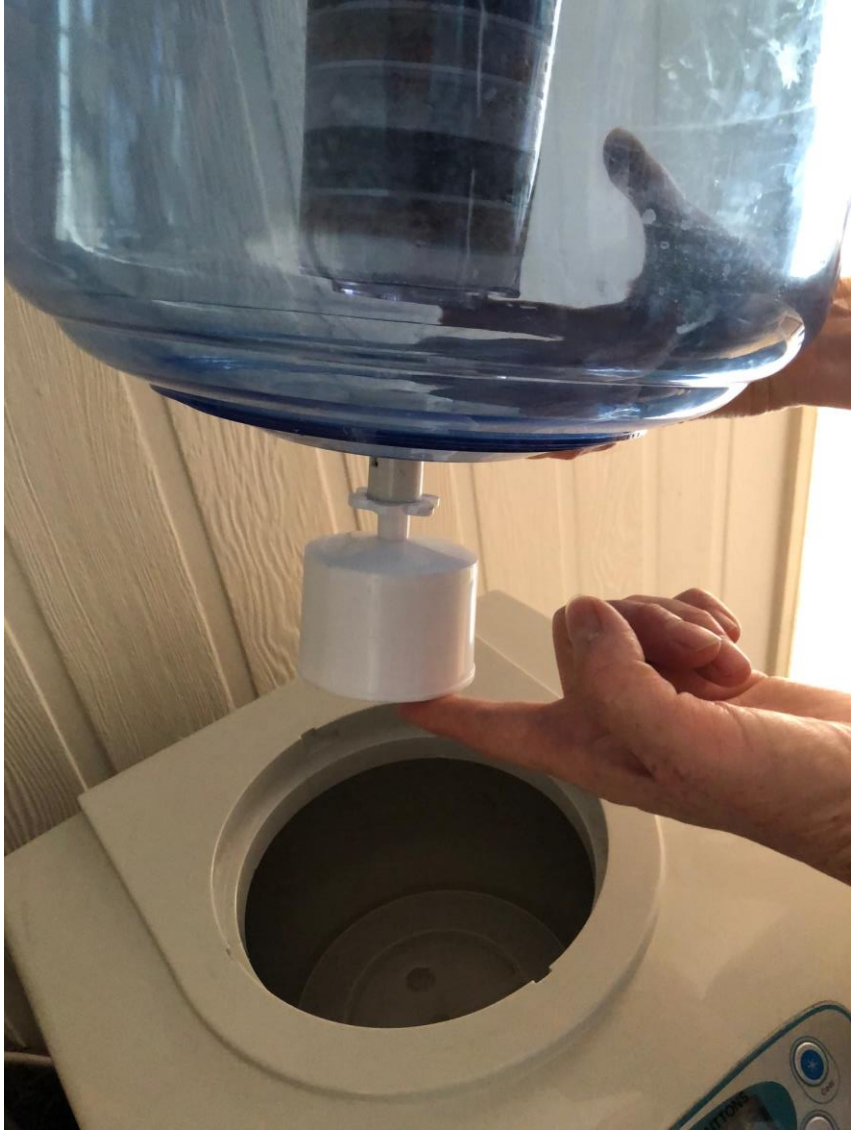
Tap the float valve with your finger a few times to make sure it hasn't gotten stuck.

The 2 parts should move freely up & down when tapped.

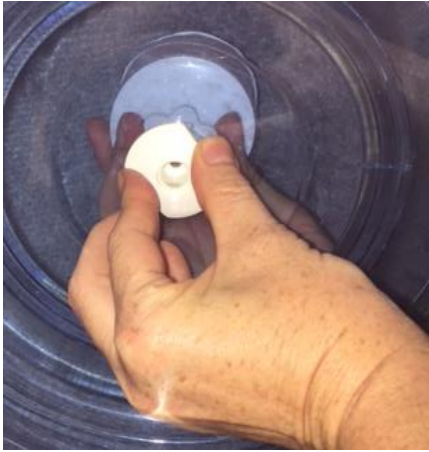
UNDO FLOAT VALVE

With your thumb on the inside of the bowl, hold onto the nut (1), while with the other hand on the outside holding onto part 2 of the float tightly as close to the bottom of the bottle as possible – twist anti clockwise.

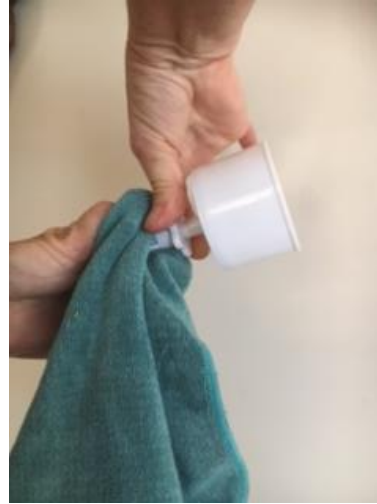
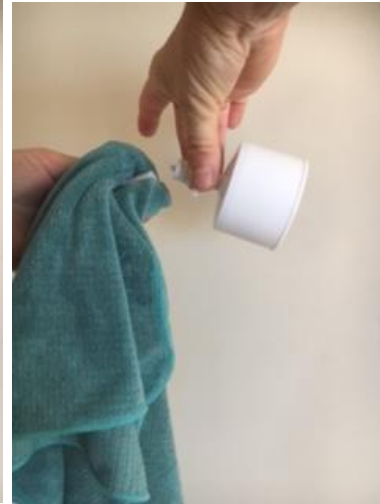
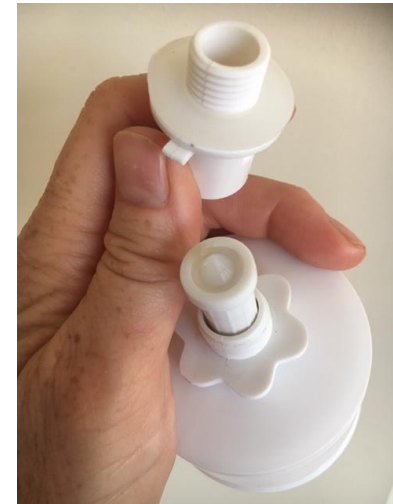
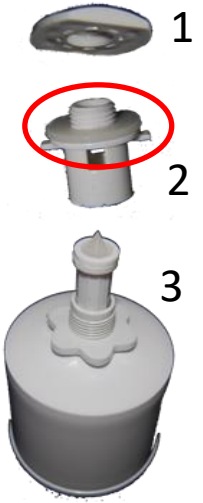
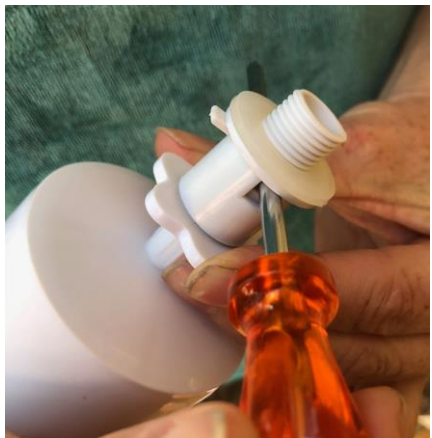
Once removed from the bowl, undo part 2 & 3 of the float by gripping it where the two parts separate and twisting anti clock wise. Sometimes it helps to use a towel to have a better grip.

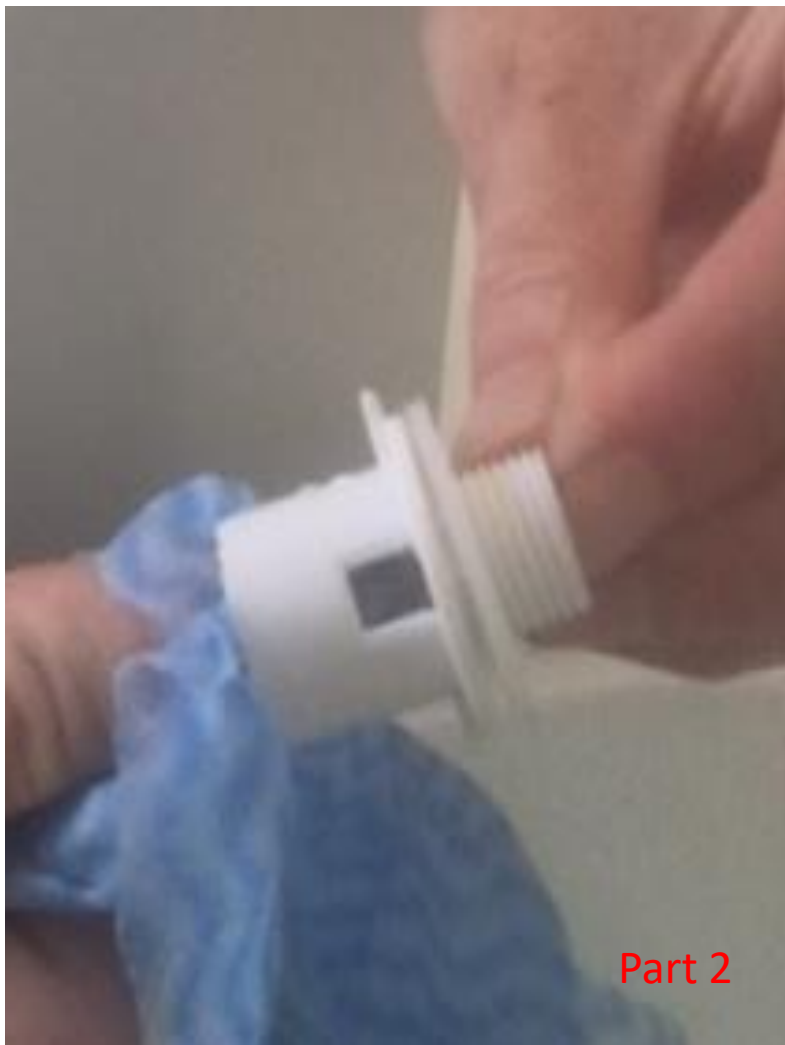
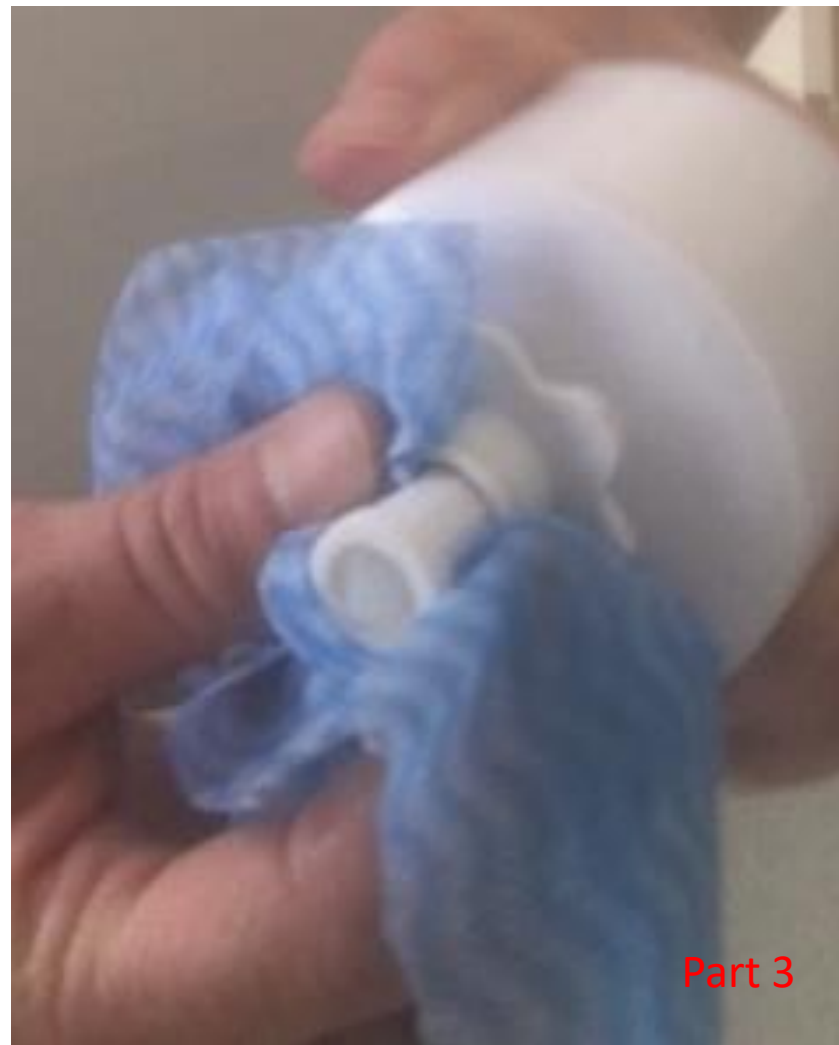
Push a small screw driver or nail through the 2 holes at the top, but be careful not to damage the nipple valve.

Now you should have a better grip to unscrew – anti-clockwise

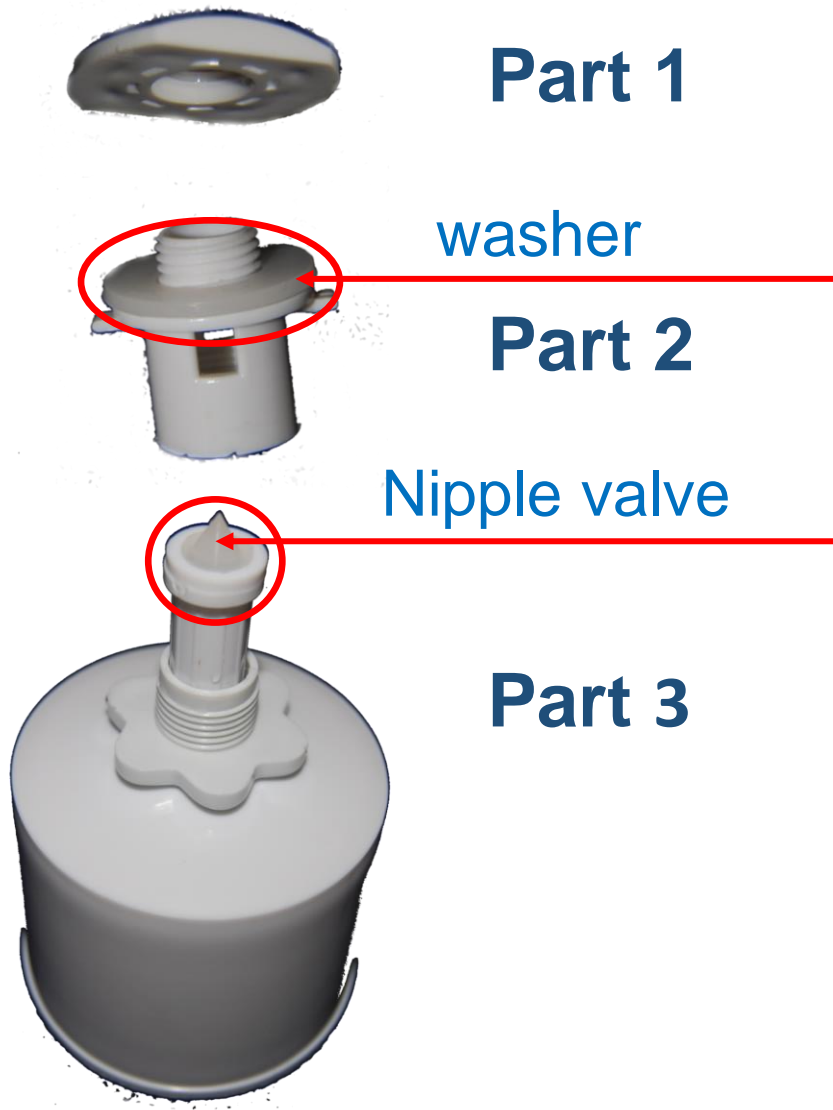
Wipe the float valve clean under running water using a NEW chux. Focus especially on the threads and the stem of part 3

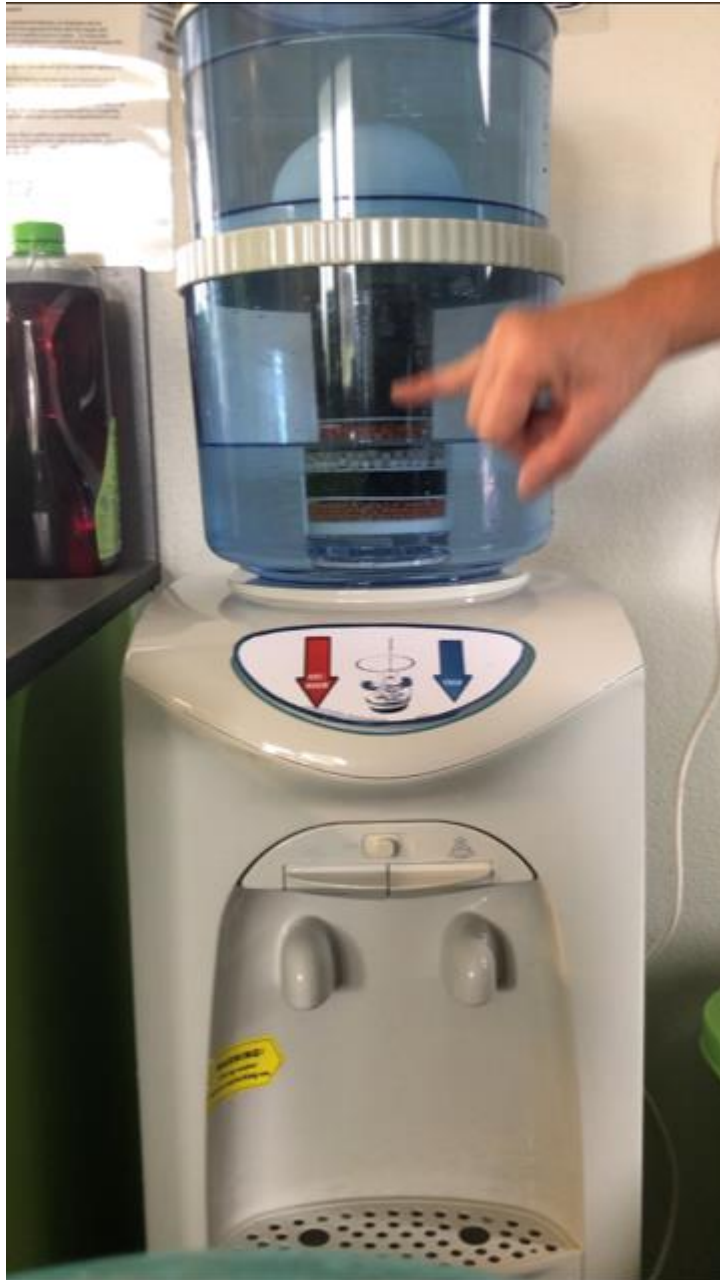
Level the bottle on the cooler

Another reason why the cooler could leak, is if the machine is not 100% level, and / or if the bowl is not locked-in to the slots in the base of the tank, which means the bowl doesn't sit 100% level on the cooler.

If not level, the float valve will not lock completely and will have a slow drip, which might eventually fill up the tank (usually overnight when not being used), and then overflow on the inside of the machine and out the bottom.

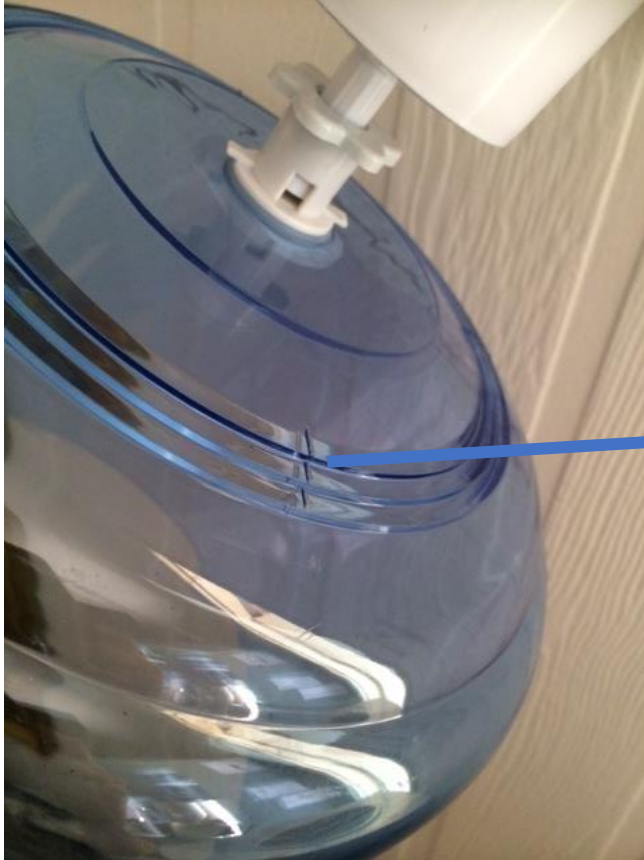
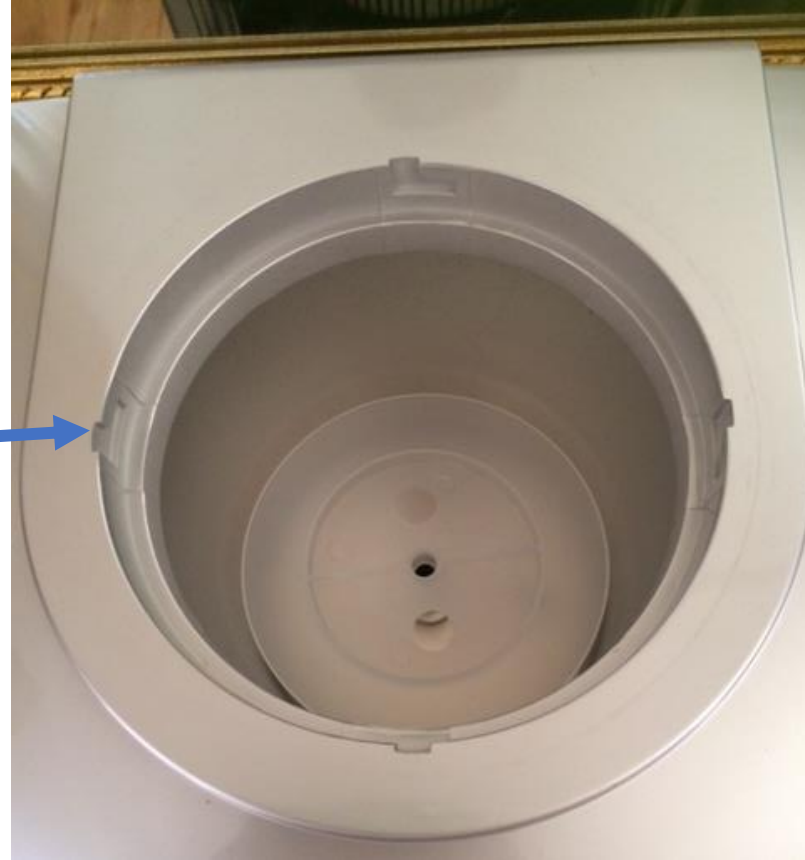
Lock the bottle into the base

The base of the bowl has grooves that needs to line up with the slots in the top of the machine. Turn the bowl until you feel the grooves “lock in”.

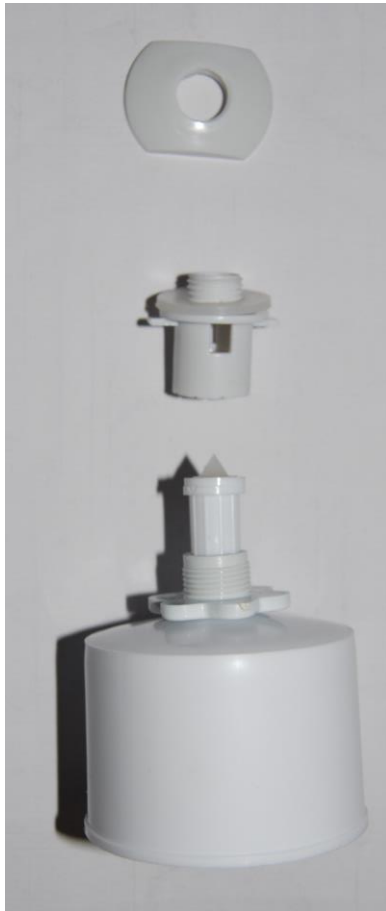
New style

- ❑ the float valve need to be replaced – thread has worn out

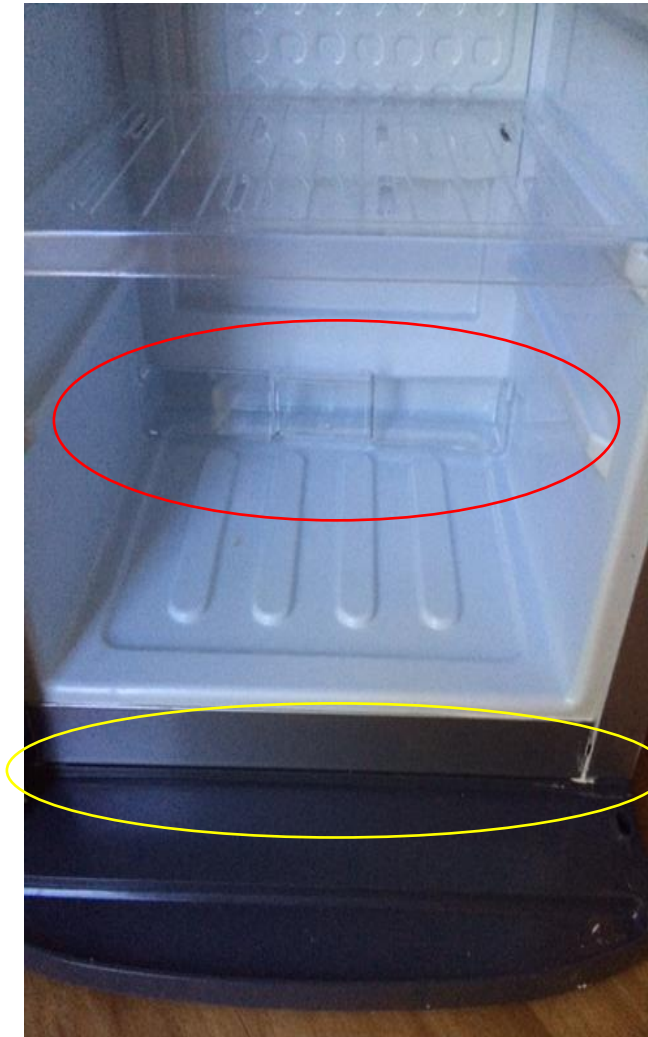
Ensure that the drip tray is in place at the back of the fridge.

Due to condensation this needs to be tipped out ($\pm 1x$ per week) to prevent spilling over into the fridge.

Drip tray

Base

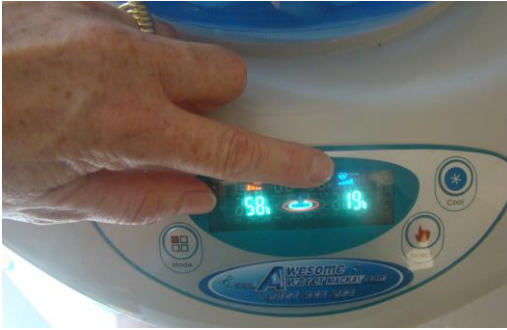
Newer models can adjust the temperature in the fridge. Set it to the highest temperature which is 8° to minimise condensation

SELECT, MODE, MODE, use heat button to increase temp to max 8°

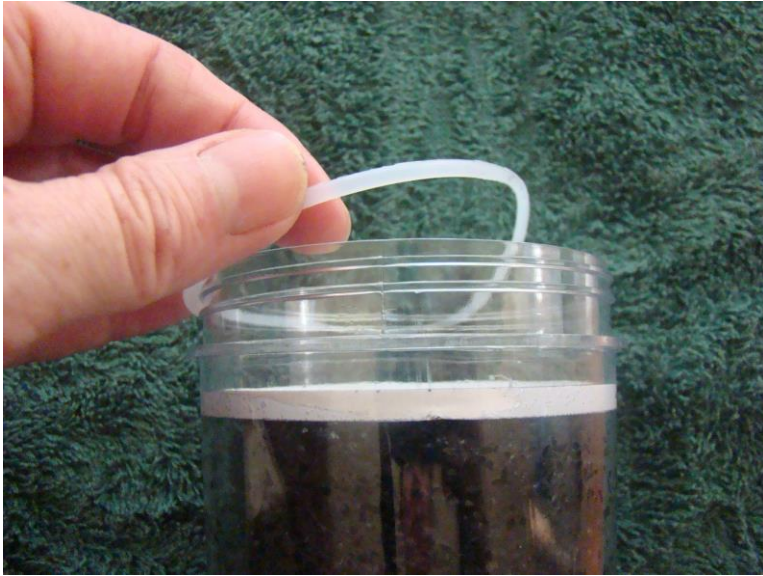
a. O-ring on neck of filter not sealing

Water is dripping on the outside of the filter, instead of going through it

O - ring at mouth of filter not securely fitted – sometimes this needs to be taken off and flipped around – make sure its flat – no twists, run your finger around the neck to make sure it's flat

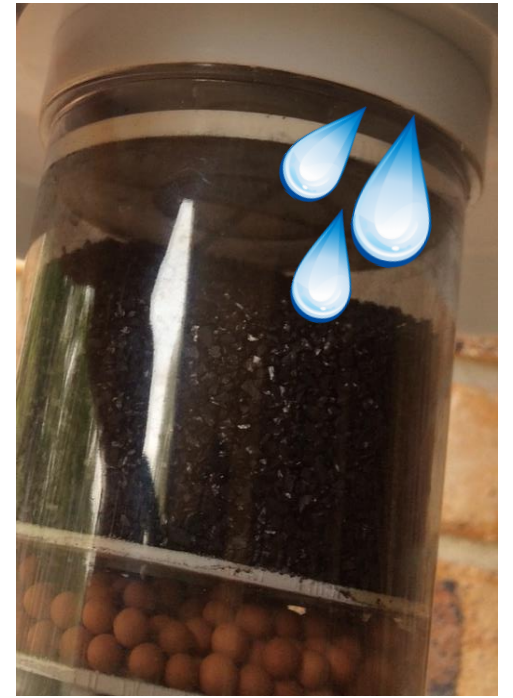
Screw filter back into the top bowl, making sure it's tight but do not over tighten

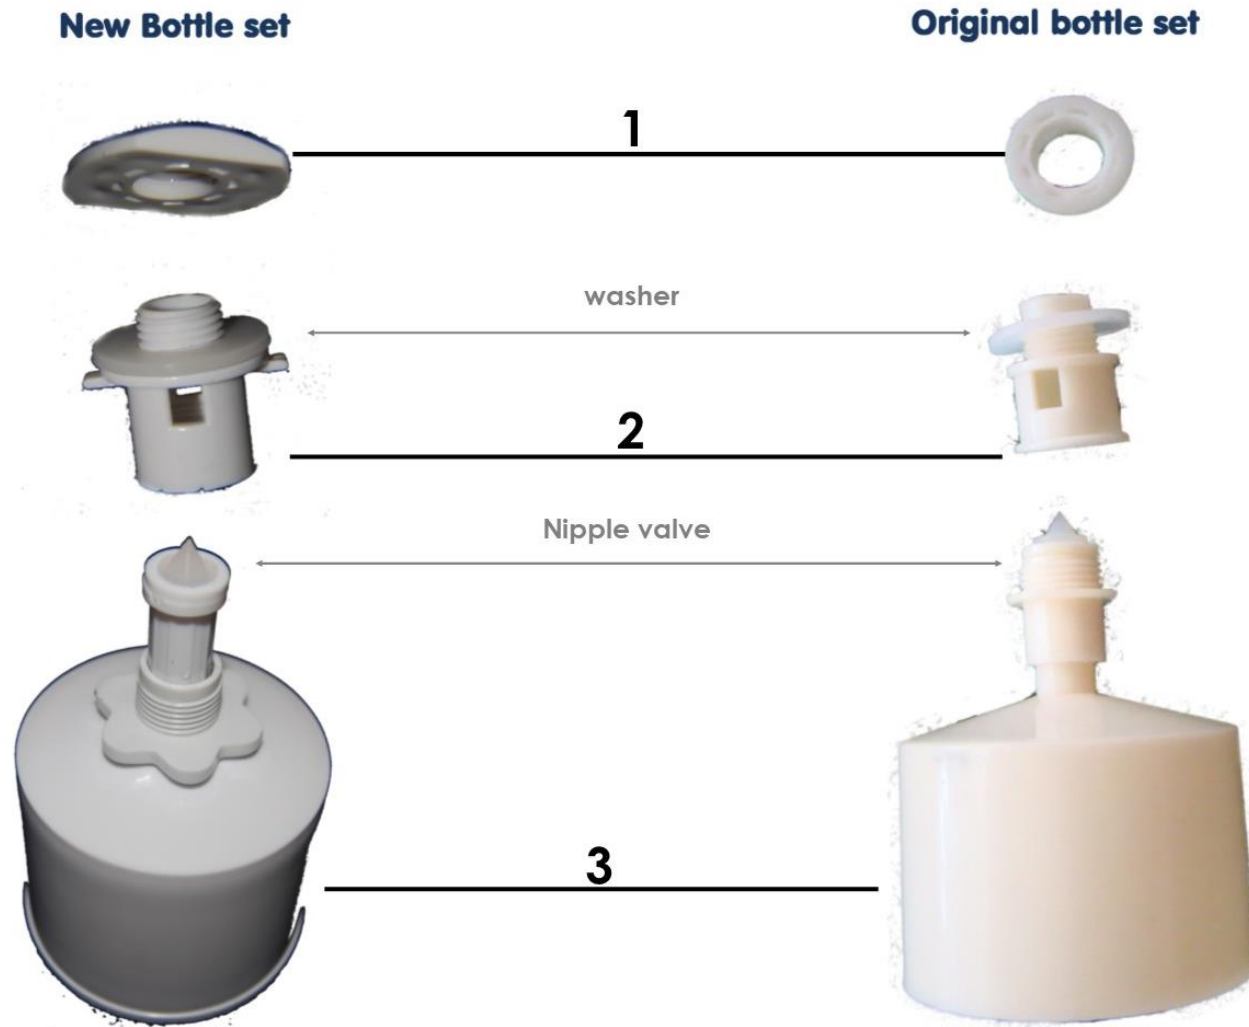
b. Washers on float valve

Make sure washers are in correct position as indicated here

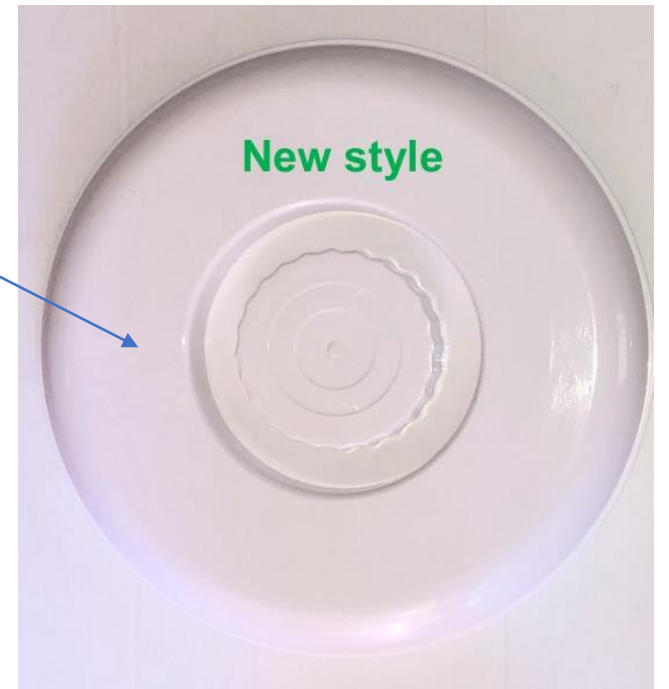
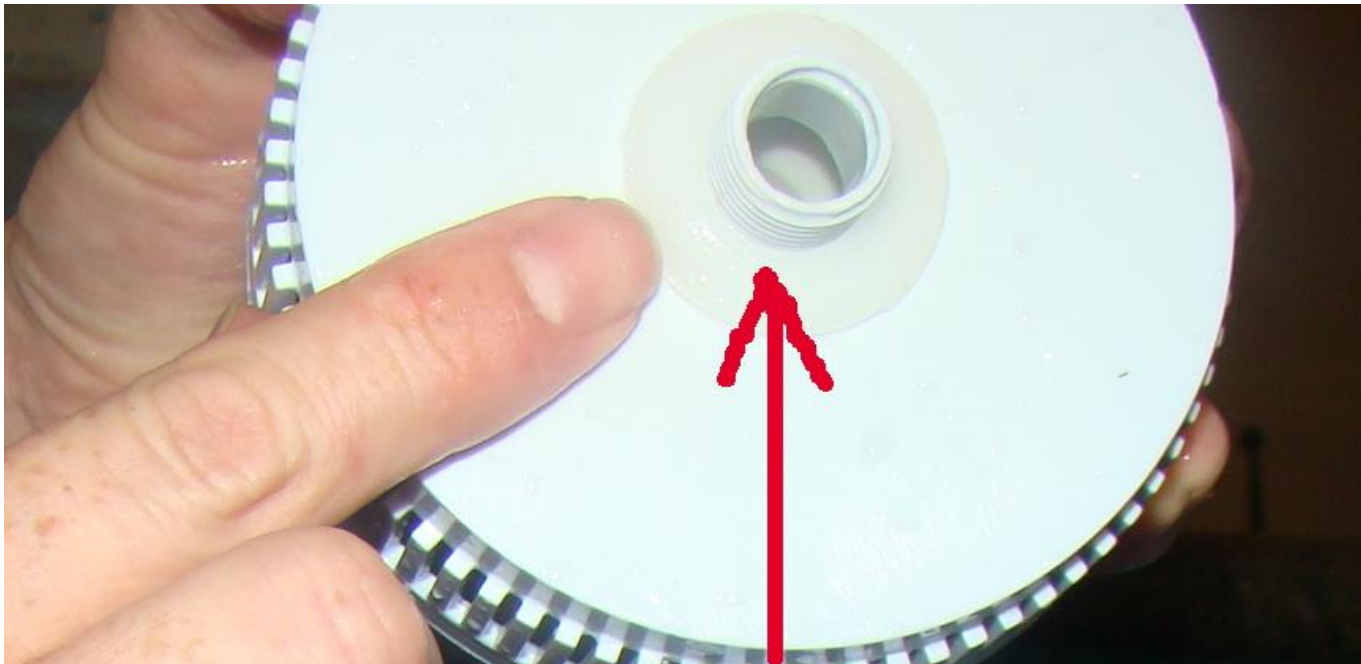
c) 1 x washer on dome (new style bottle set)

Make sure washers under the dome is in the correct position as indicated here

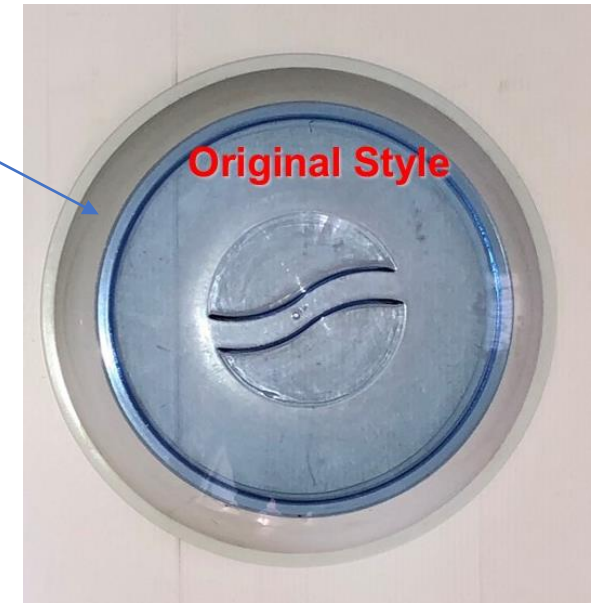
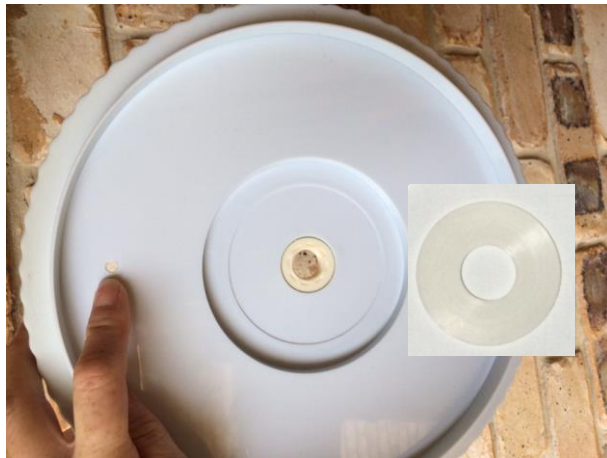
d) 2 x washers on dome (old style bottleset)

Make sure washers under the dome is in the correct position as indicated here

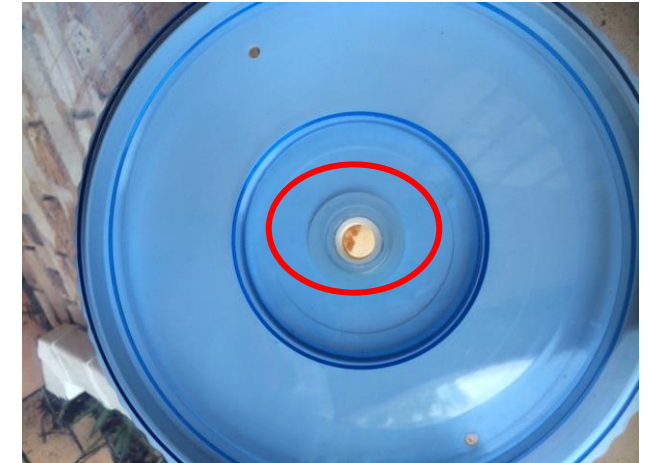
Make sure the large washer is inbetween the white plate & the top bowl

Screw the dome back until you can feel it grip, but do not force

If the dome doesn't screw on and keeps spinning around, either dome or white plate needs to be replaced.

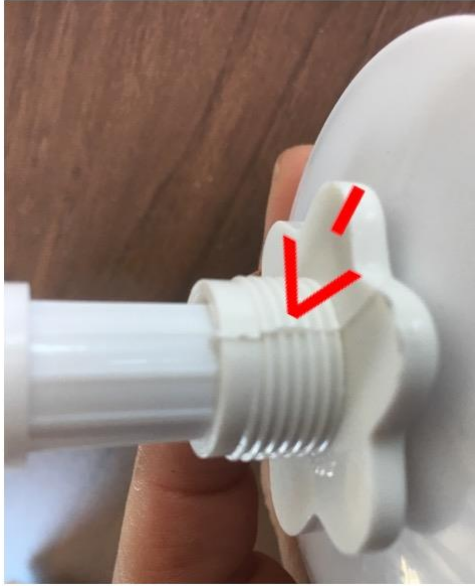
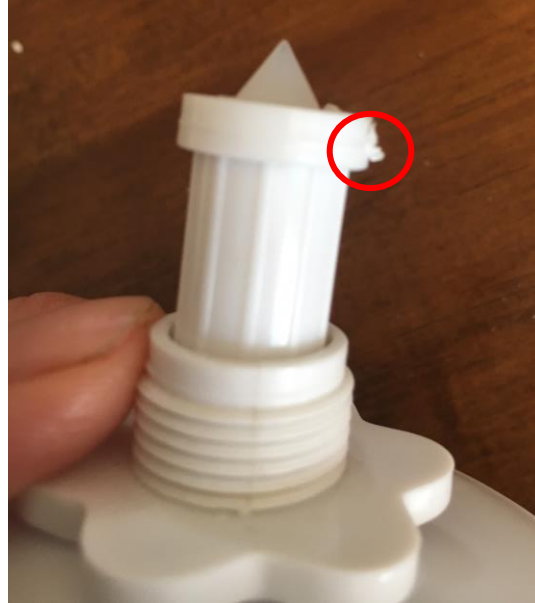
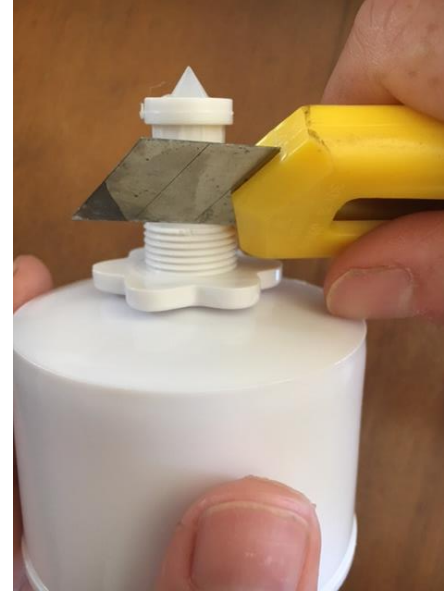
3. float valve has excess plastic – not sealing properly

Use a Stanley knife to cut / scrape off the excess plastic bits

- Excess plastic on the tread and stem or on the top of the stem
- This would cause it to not seal properly and slowly fill up the tank until it overflows on the inside and then run out the bottom
- **We do try and check this on installation, but sometimes we can miss it**

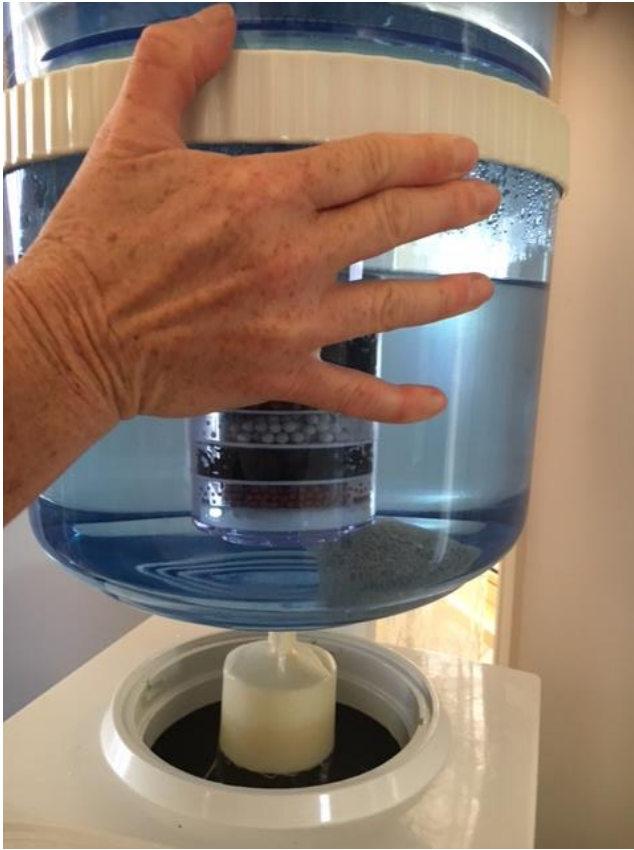
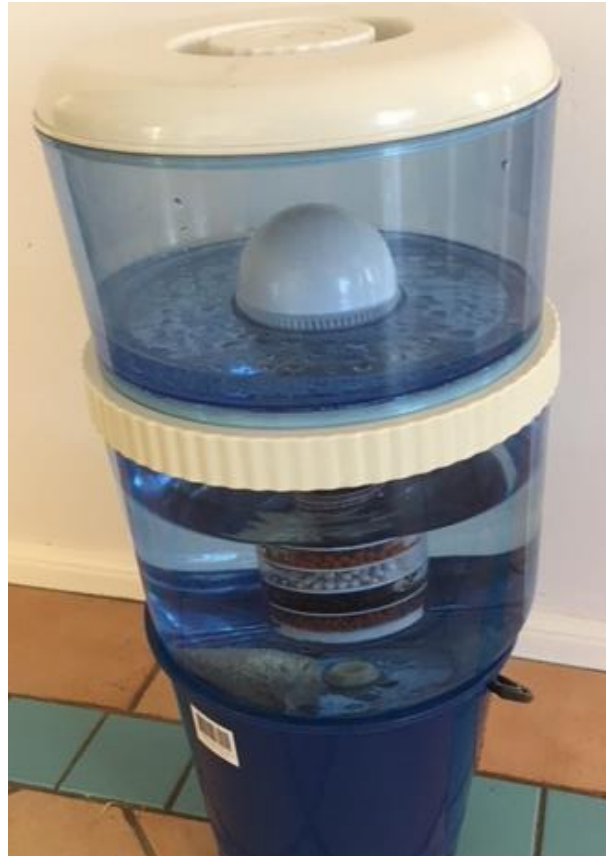
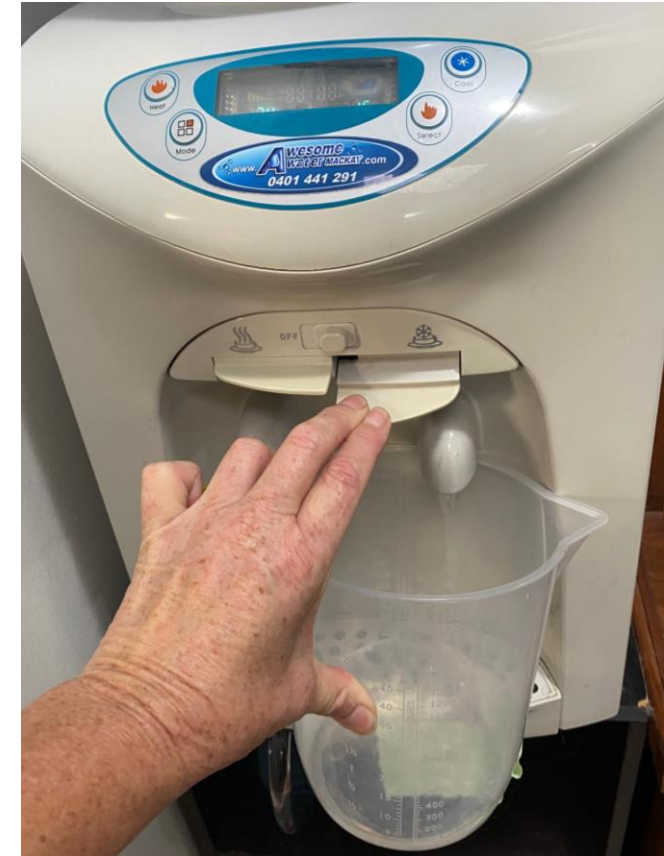
Lift the bowl out of the machine - be careful – the top & bottom bowl are separate pieces - pick up on **bottom** bowl part ! Obviously, this will be easier to do when the water level in the bottle is low. Have a bucket handy to place the bowl into Drain the tank by running the cold water tap completely.

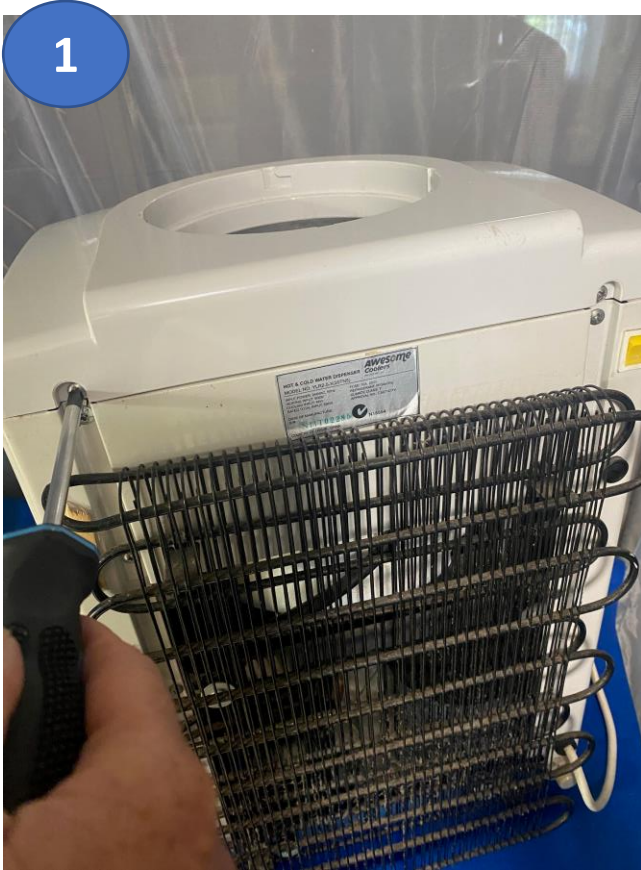
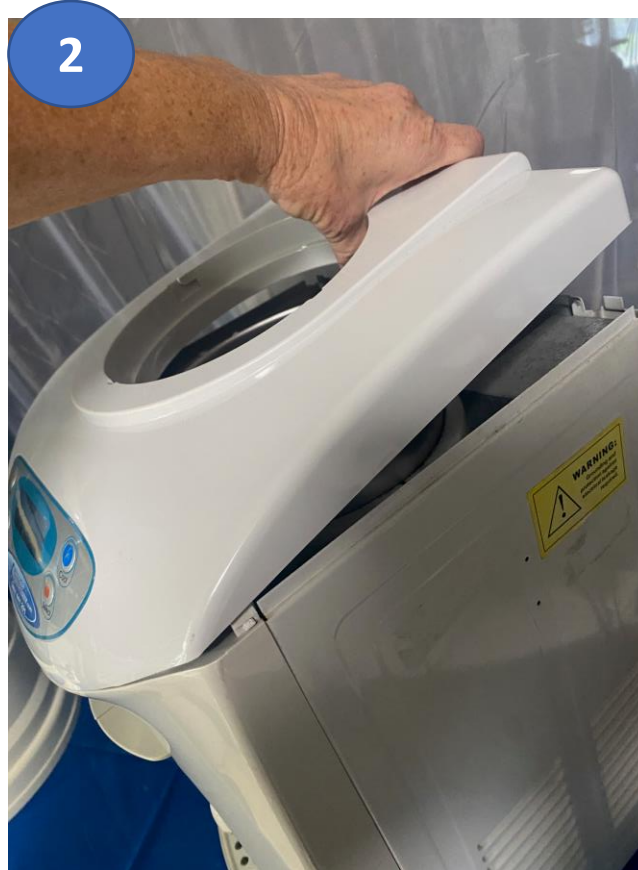
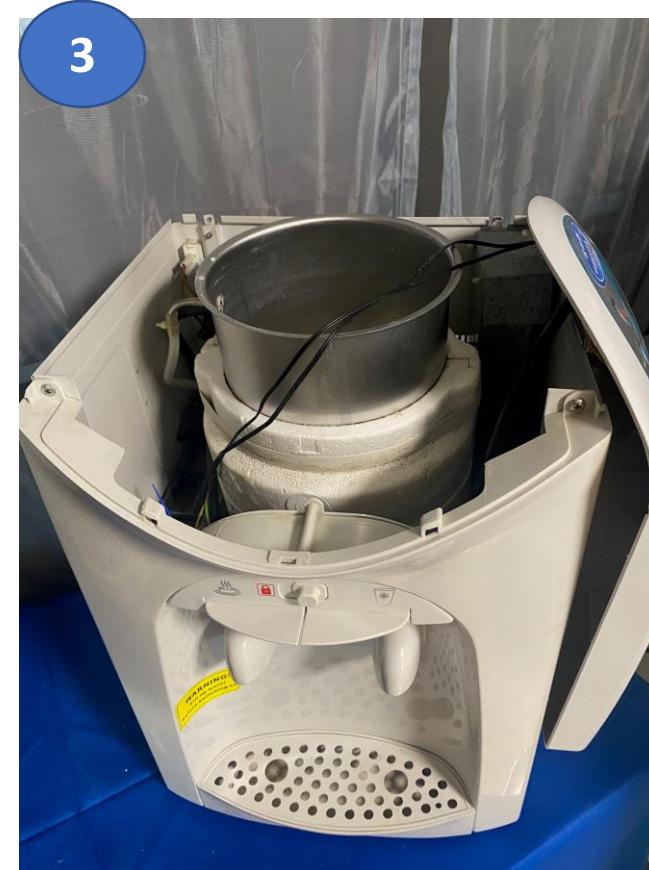
TURN POWER OFF & UNPLUG

1. Unscrew 2 x screws at back of machine
2. Gently wiggle loose the lid
3. Remove lid ensuring that wires stays intact
