Cooler leaking from bottom

Reasons for float not locking

95% of leaks are due to the float valve not locking properly

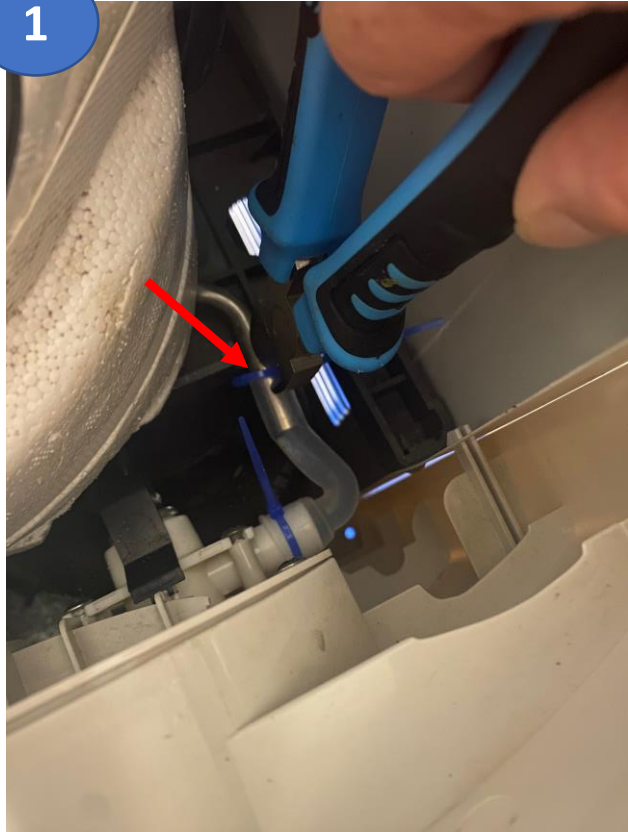
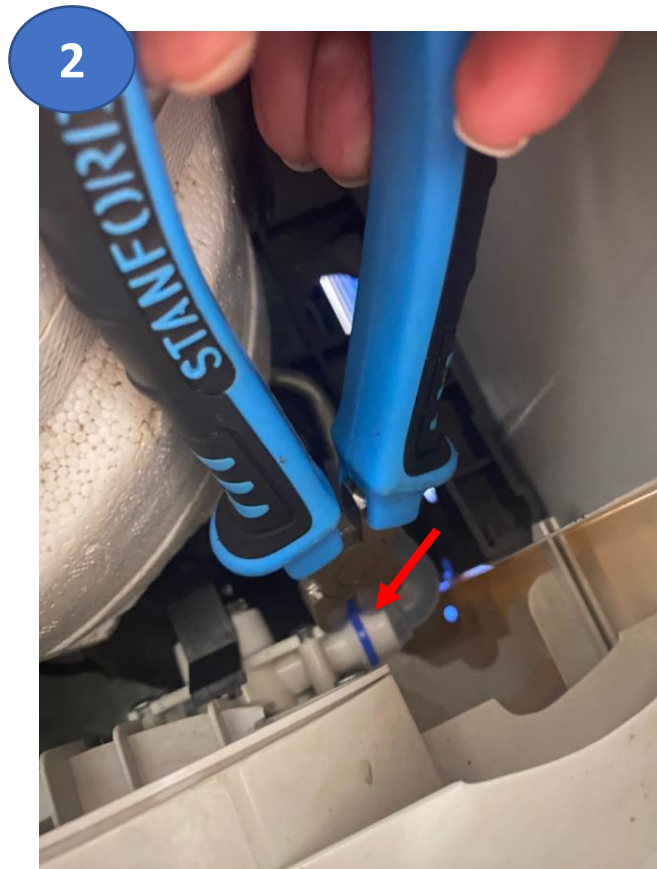
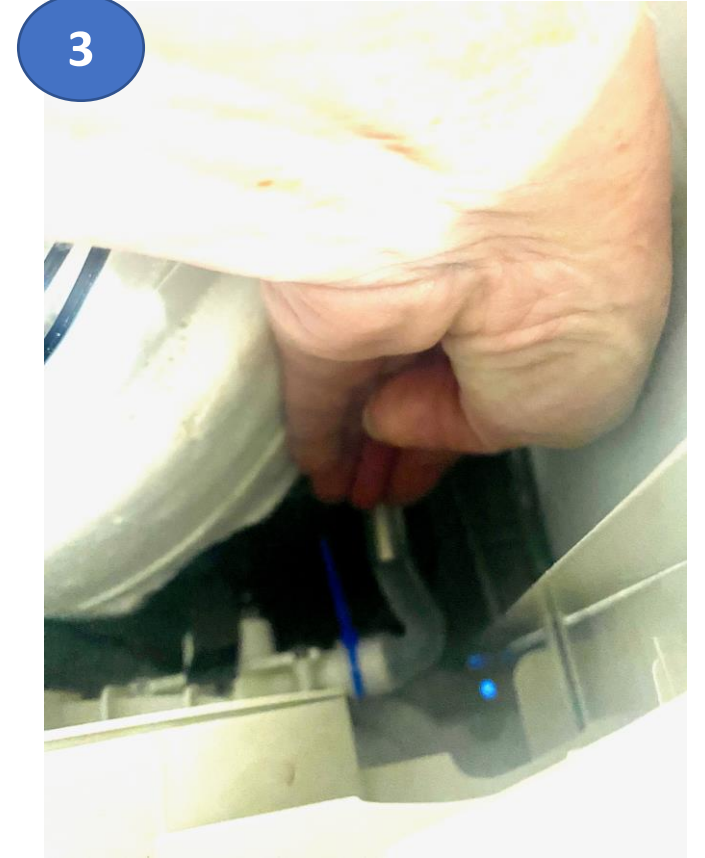
Using a side cutter, cut the zip ties that's fastening the silicone pipes to the machine at both ends (1&2).

Push / pull pipes leading from the steel pipe to the tap (3) - This could be hard to remove and might need to use fingers to force off pipe from the pipe section.

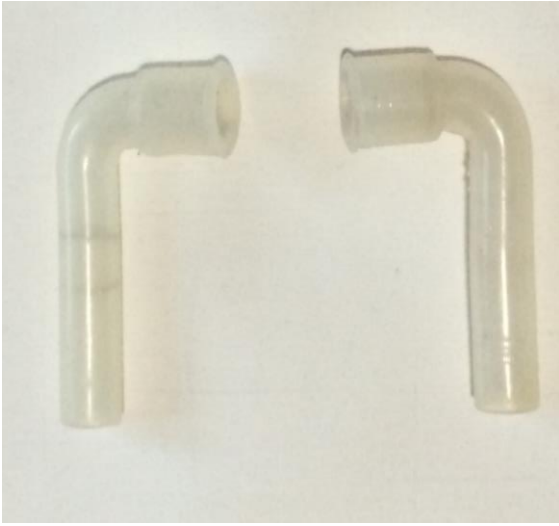
Remove 2 X Silicon pipes and check for any damage

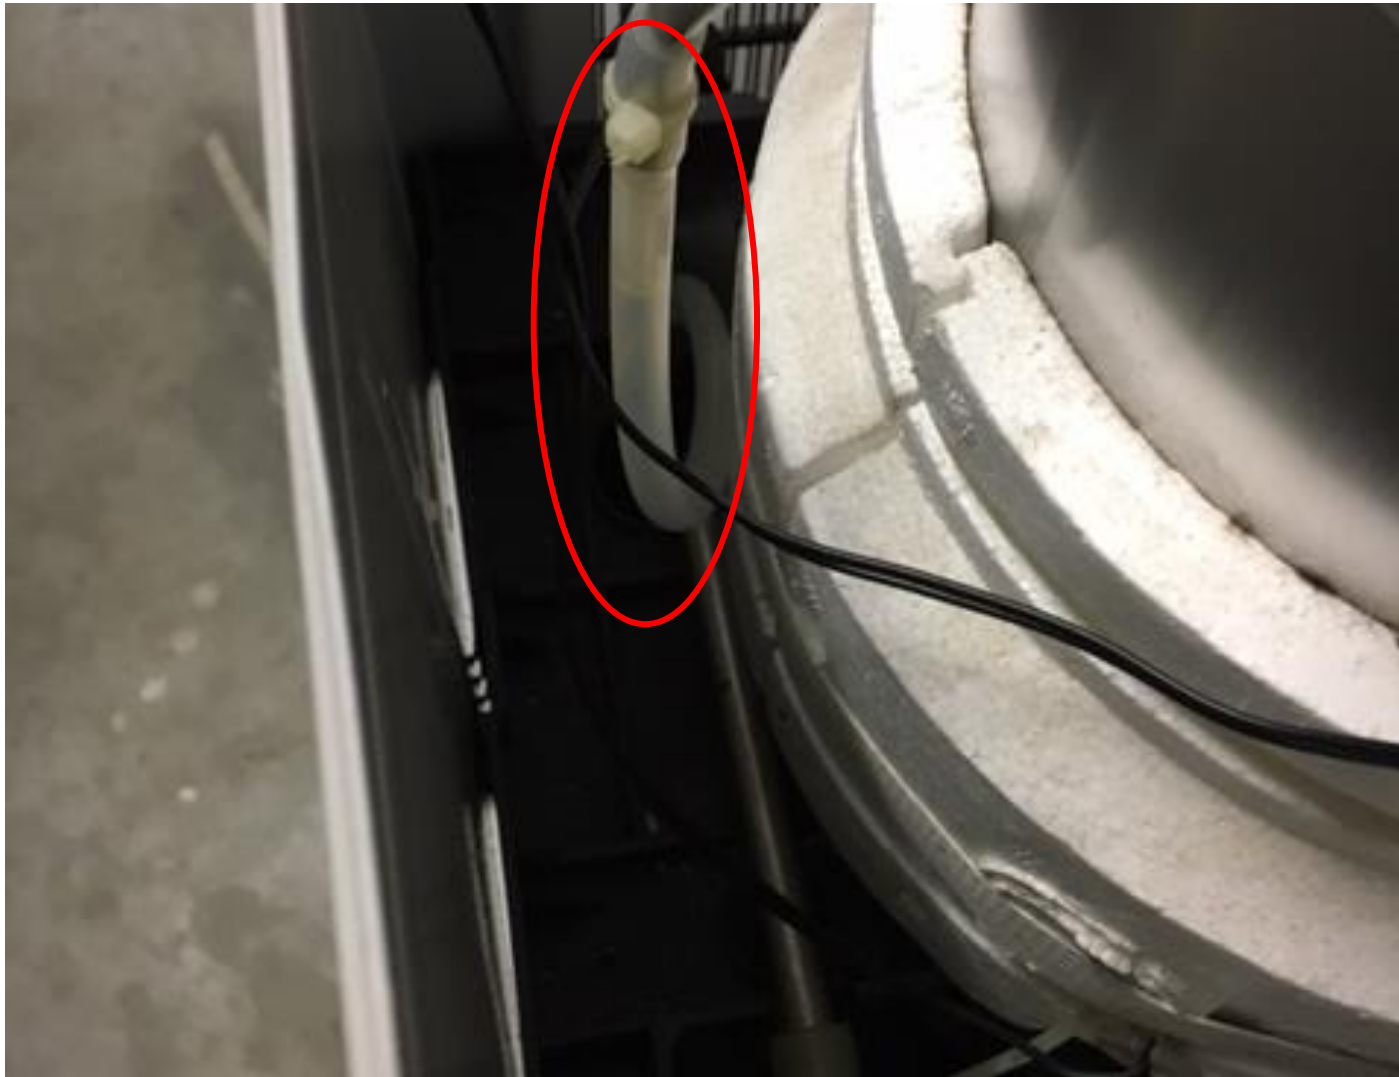
Check hot return pipe on left side of tank for any damage

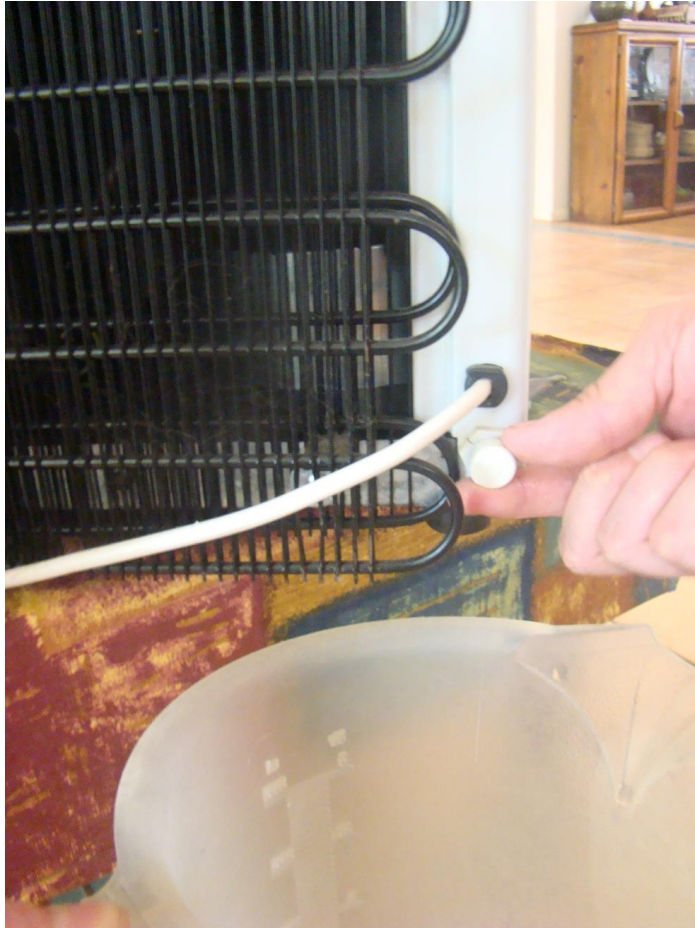
Unscrew the plug at the back to drain the hot tank.

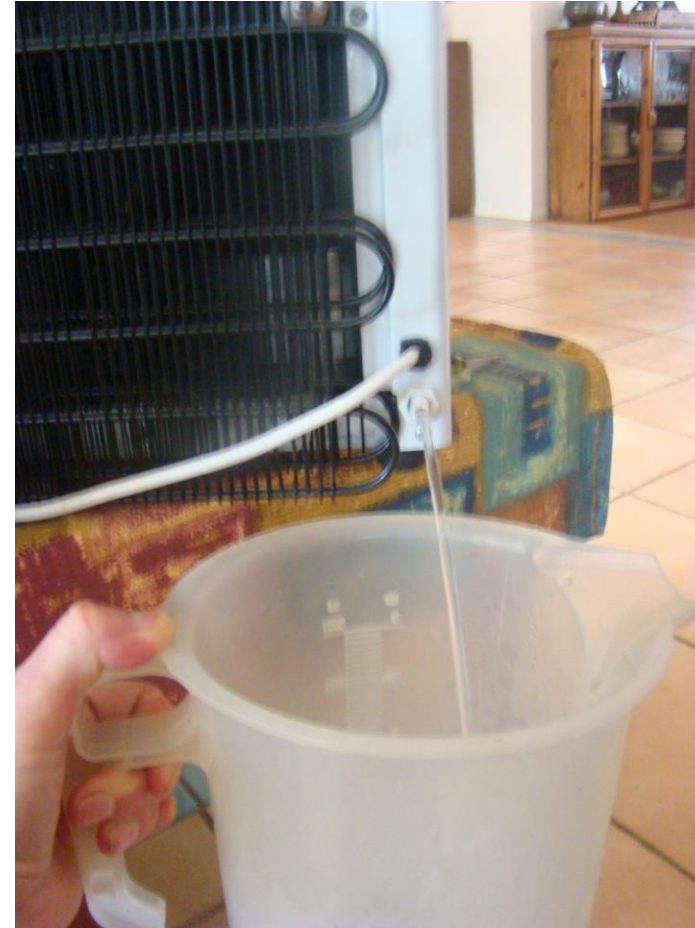
Have a bucket / jug ready to catch water – be careful if you have hot water on – this water will be hot !

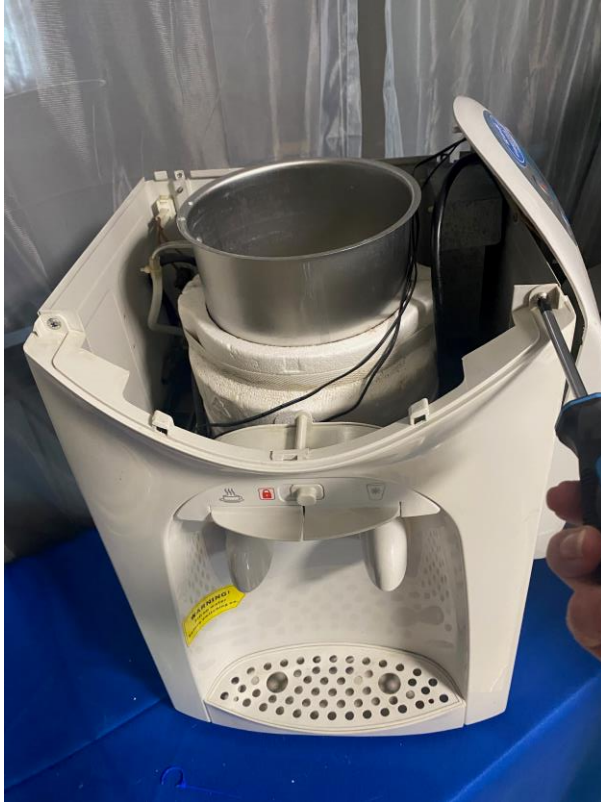
Remove 2 x screws at the top front once lid has been removed.

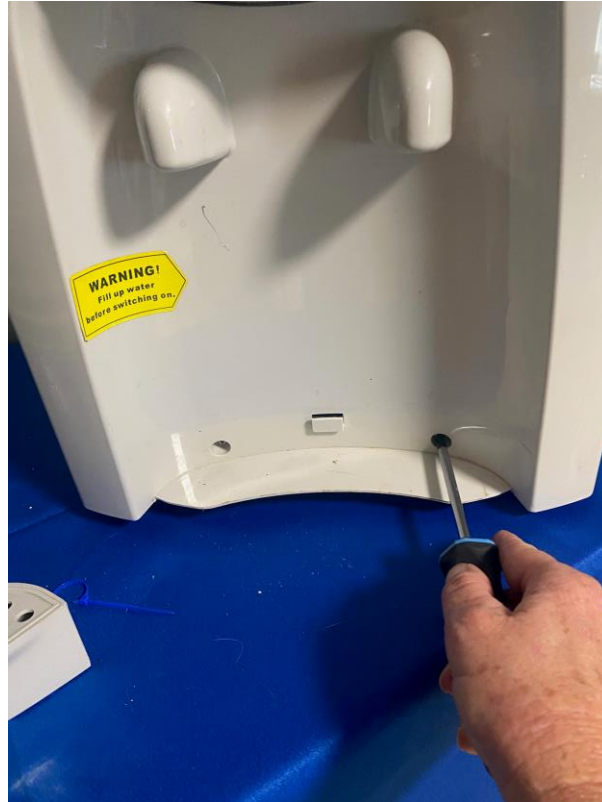
Remove drip tray & unscrew 2 x screws behind.

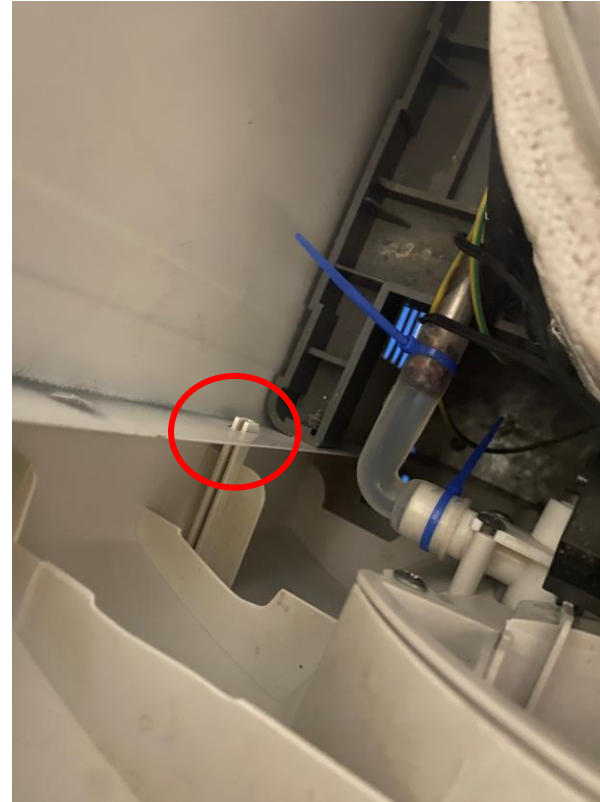
Unclip hooks on the both sides, slightly lift to unhook

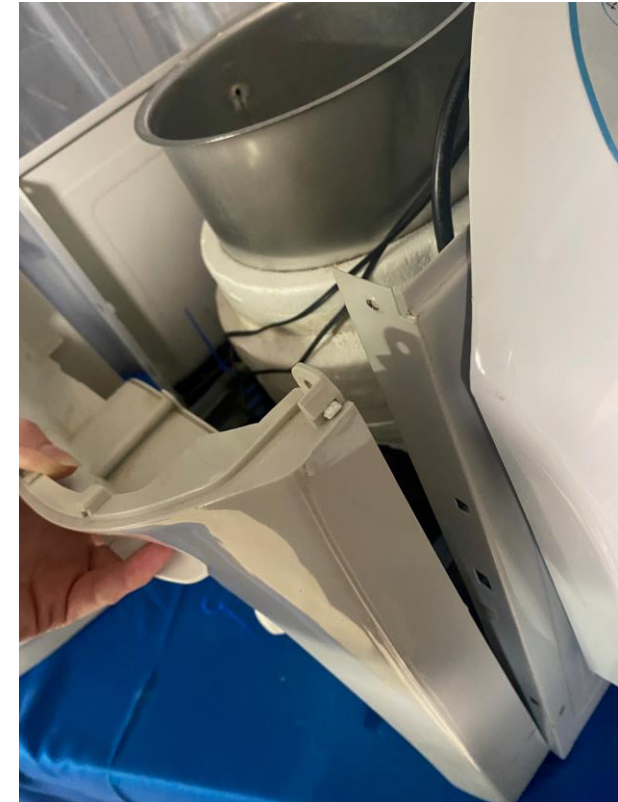
Front face can now be removed

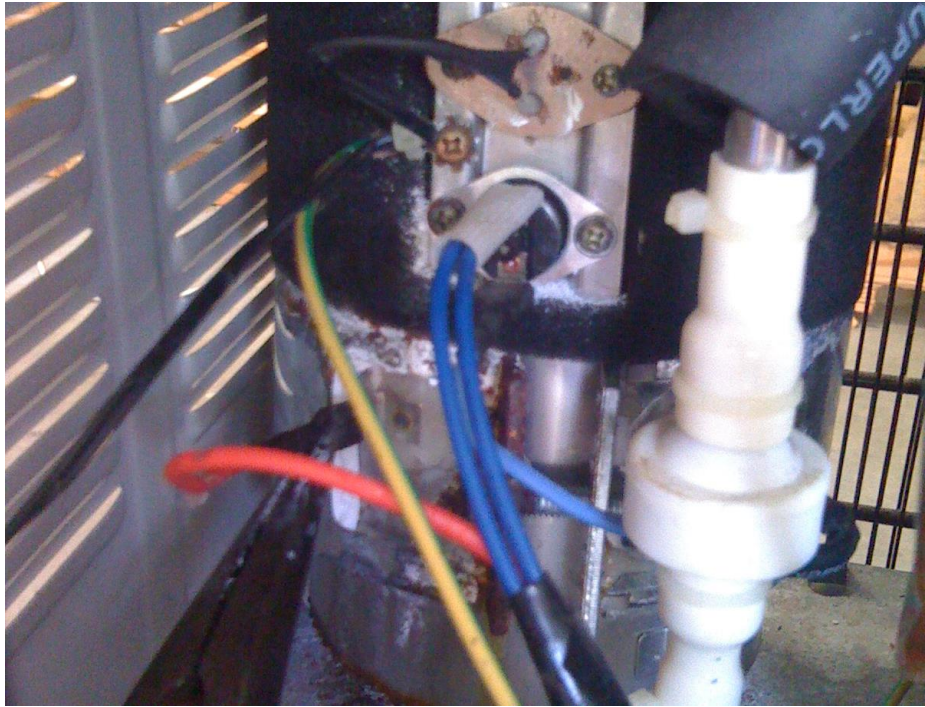
Check one way valve for any damage

This could be hard to see, but if you have lots of calcium build-up around the valve as in this picture, it's a sure sign of a leak.

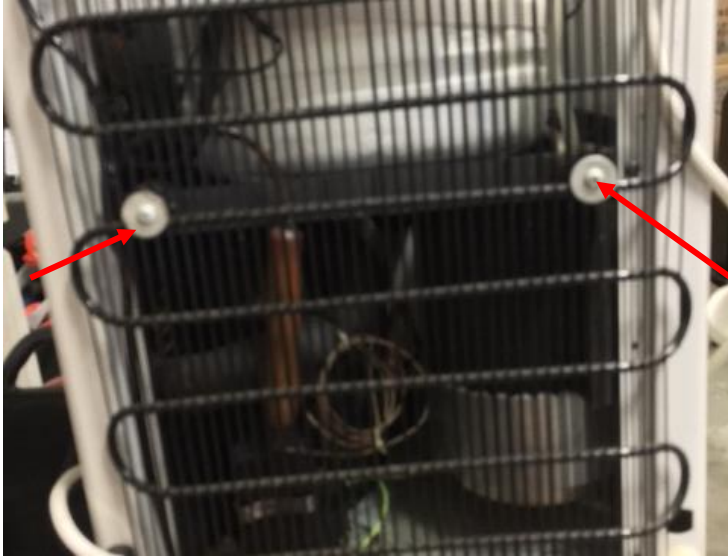
Undo 4 x screws on back grid
& twist open – be careful not
to twist to far as this will
damage compressor coils

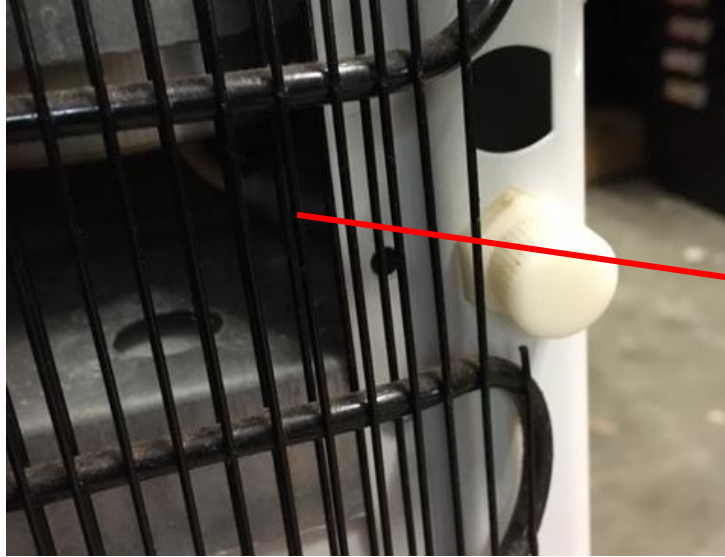
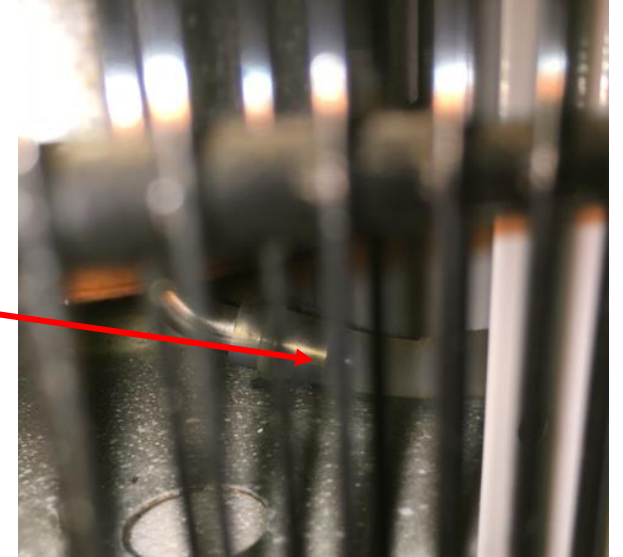
Check for any damage on the back drain
pipe

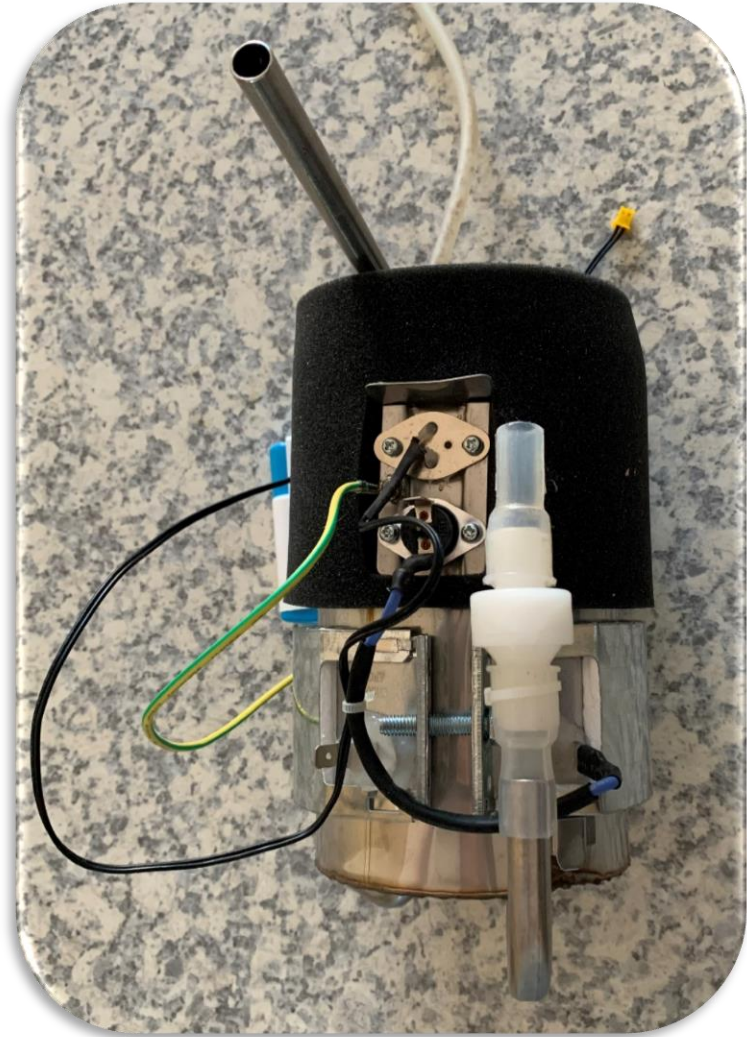
If no damage to any pipes, it's most likely the kettle that has rusted through, and entire kettle will need to be replaced.
